# ALUMINIZED STEEL TYPE 2

## FABRICATION DATA

Technical Bulletin

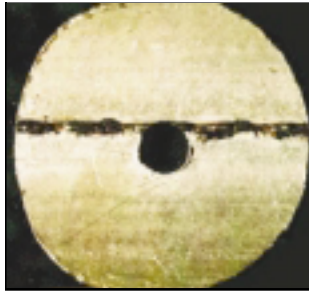
Comparative weld-seam condition in the inverts of aluminized and galvanized pipe in corrosive water. Aluminized shows no deterioration of the weld or the coated surface. Galvanized shows loss of zinc coating and scattered pitting in the substrate.

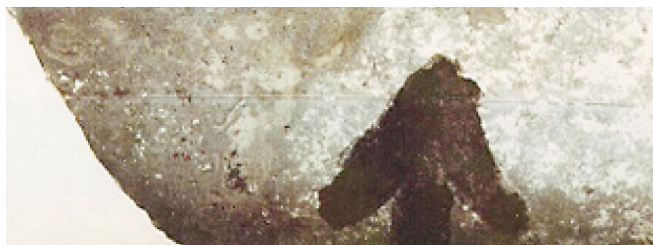
Thirty-year-old aluminized uncoated edge on a triangular notch cut from an invert handling water corrosive to galvanized. The undeteriorated edge is indicated by the arrow.

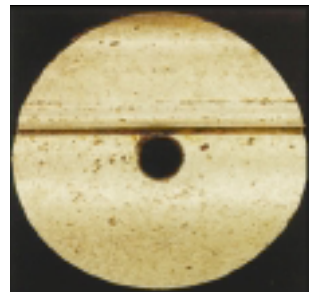
Invert-Waterside

Undeteriorated lockseam on ten-year-old Aluminized Type 2 Pipe.

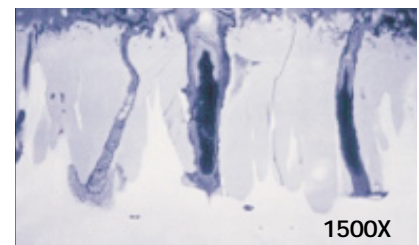
Voids in the corrosion product in fissure cavities are still present after 30 years exposure in the field. This shows that initial substrate corrosion at a fissure base is stifled very early by corrosion product that plugs the fissure, even before the cavity is totally filled. Eventual reactivation

of corrosion at a fissure base occurs, as illustrated by the development of detectable substrate corrosion and cavity filling at one of the fissures in the photo.
